ENERGY SOLUTIONS FOR THE KIENZLE FAMILY

WHITTIER, CA

Kienzle Home Energy Assessment

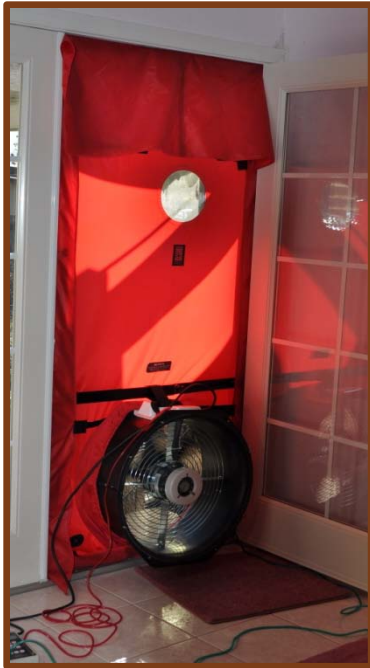
Measured: 9500 CFM50

Target: 2567 CFM50

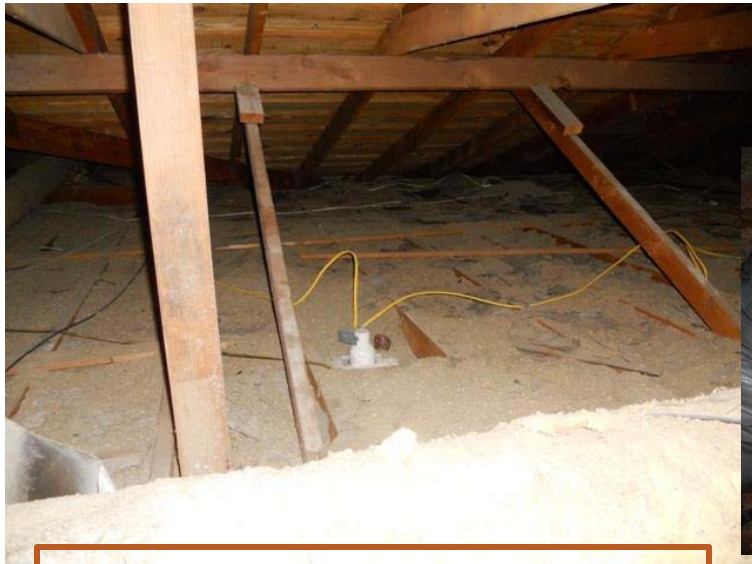
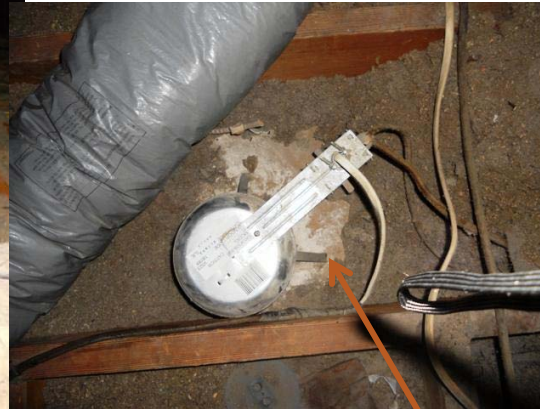
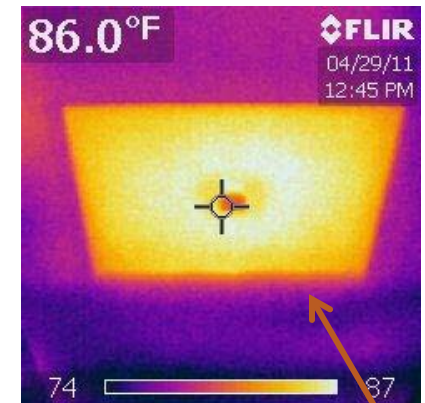
Attic insulation is currently blown cellulose performing at a R-13 because of age and voids. There is no air sealing around penetrations.

Current fixtures are not air tight or insulation certified allowing for attic air to be pulled into living space.

Insulate attic access that is allowing heat and cold to bypass insulation

Target Insulation level : R-38

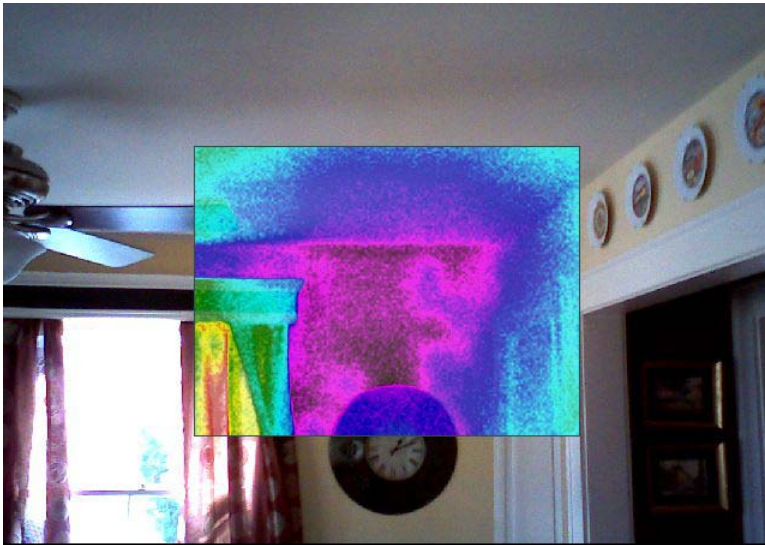
Wall Insulation- There is no added insulation in the exterior walls of your home. It was built prior to County and City building codes requiring the addition of insulation.

Thermal image scan showing the absence of insulation.

Target insulation level is R-13 or greater.

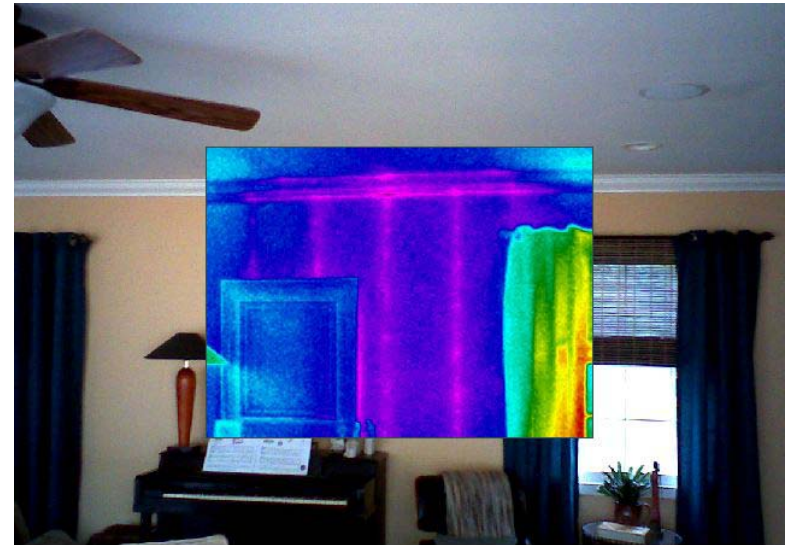
Thermal image scan showing the presence of insulation between framing.

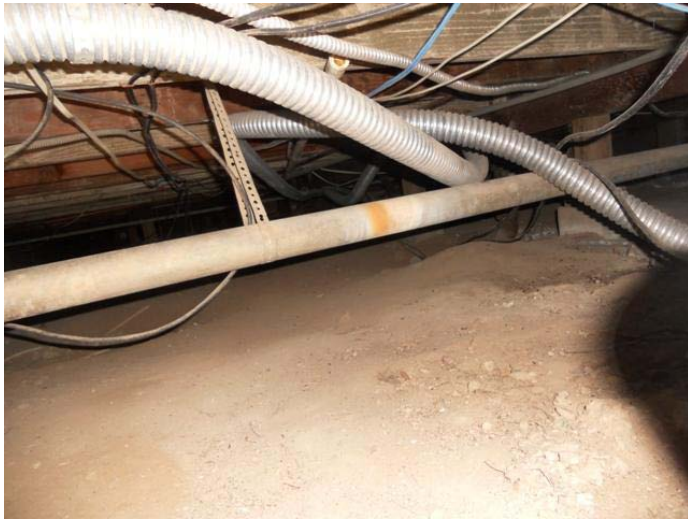
Crawlspace Insulation- A crawlspace or subfloor that is not sealed or insulated allows unconditioned air to be drawn into the home. The lack of insulation causes heating and cooling equipment to work harder to maintain a constant temperature because of the inconsistent temperature of the flooring.

Crawlspace without air sealing allowing for unconditioned air and dirt to be drawn into the home.

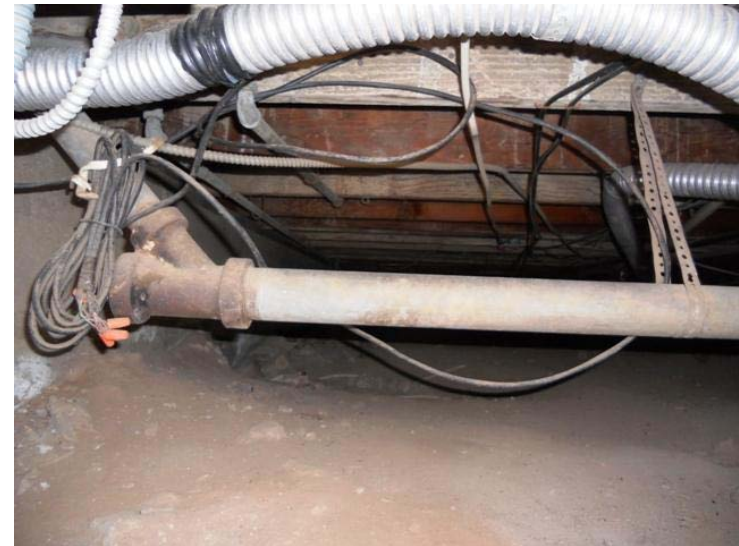
Another view of the subfloor without insulation or a vapor barrier.

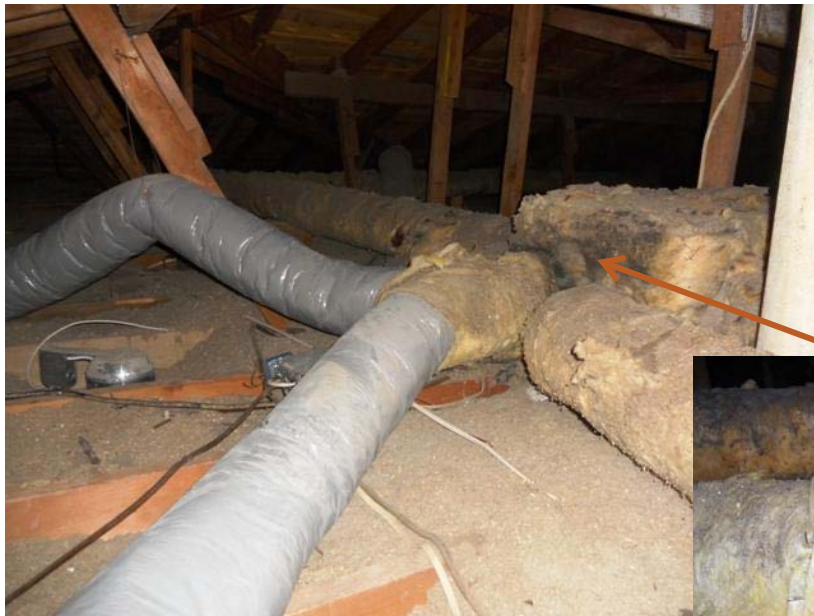
Current duct insulation: R-2

Duct Leakage: 760 CFM

Measured leakage using BPI standard duct blaster test

Target duct insulation is: R-8

Allowable duct leakage is: 160CFM

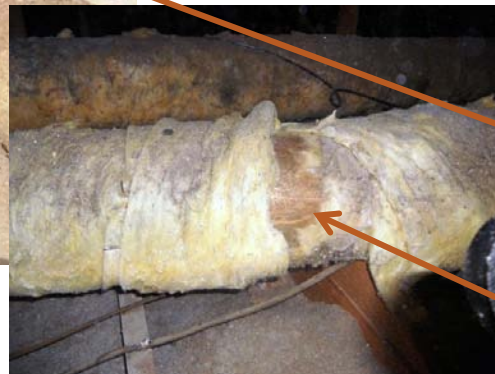
Ducts are poorly insulated and exposed to heat of attic. Some ducts are damaged.

Ducts are not sealed properly allowing unconditioned air to be drawn into home.

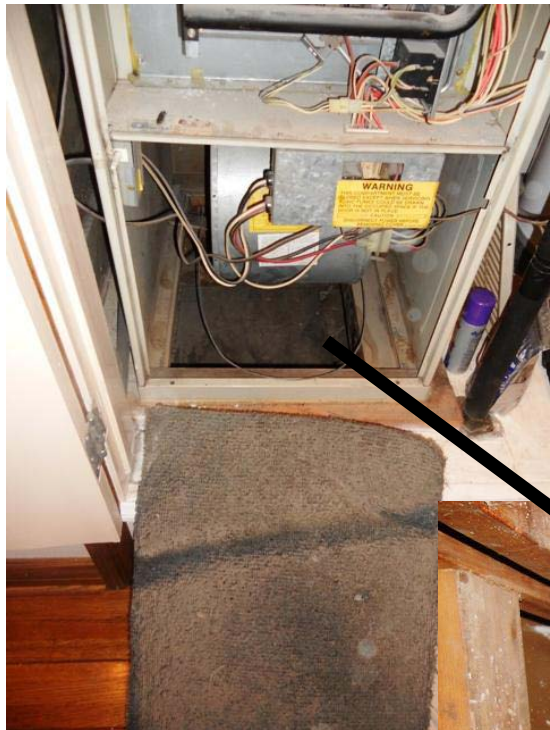
Washable filter is dirty which is restricting air flow from furnace. Furnace is sitting on return air box with exposed framing. This configuration allows for unconditioned air to be drawn into furnace and for excessive duct leakage.

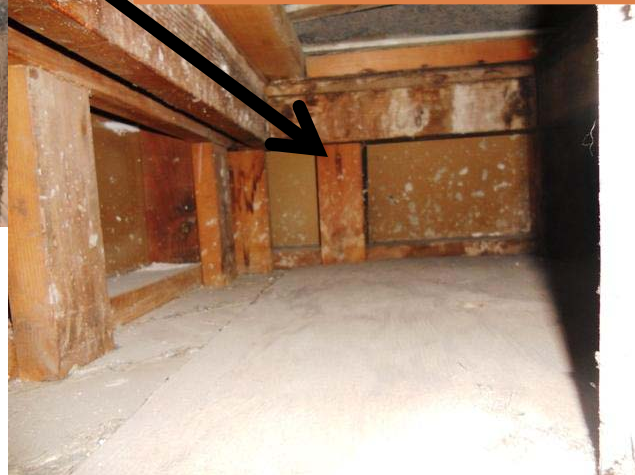
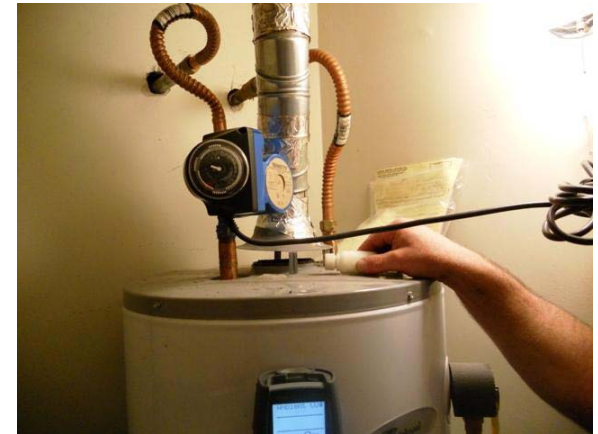
Existing water heater failed exhaust gas spillage test.
